Subject: Sunshine Canyon Landfill, Quarterly Vegetation Report
Third Quarter 2025 Vegetation Report

This report presents the progress of the site's landscaping and revegetation activities for the third quarter of 2025. The intent of these reports is to provide detailed information regarding the site's efforts related to vegetation including vegetation of interim and permanent slopes and activities conducted for the on-site sage mitigation areas.

On September 18, 2025, Rincon Consultants performed the third quarter qualitative monitoring of 2025 for the Republic Services City-Side Sage Mitigation Area. This report qualitatively documents the current conditions of the City-Side Sage Mitigation Area with regards to the Landfill's coastal sage scrub restoration efforts. The City-Side Sage Mitigation Area consists of the Lower Deck, Middle Deck, and Upper Deck (including slope between middle and upper decks), which are discussed in detail below.

FIELD OBSERVATION REPORT

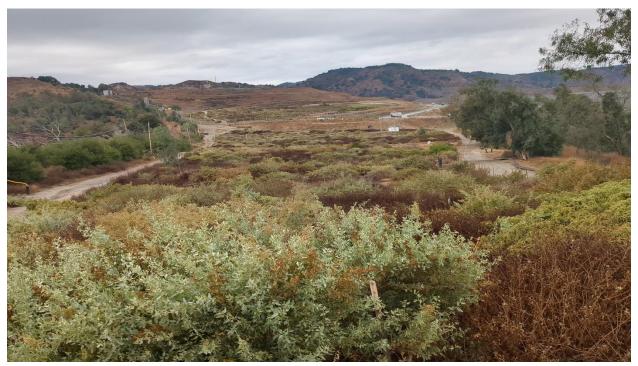
Photograph 1. Facing west at Lower Deck. View of eastern limits dominated by *Atriplex* spp. and California sunflower (September 18, 2025).

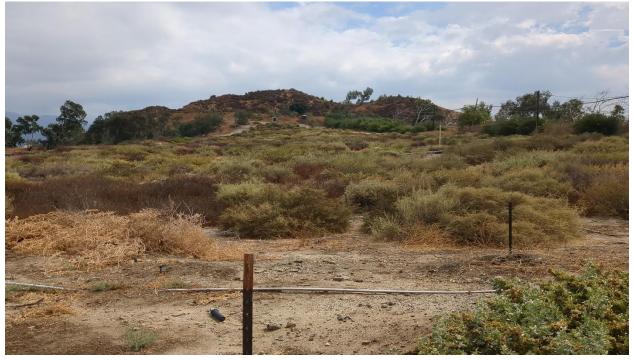
Photograph 2. Lower Deck from western boundary (September 18, 2025).

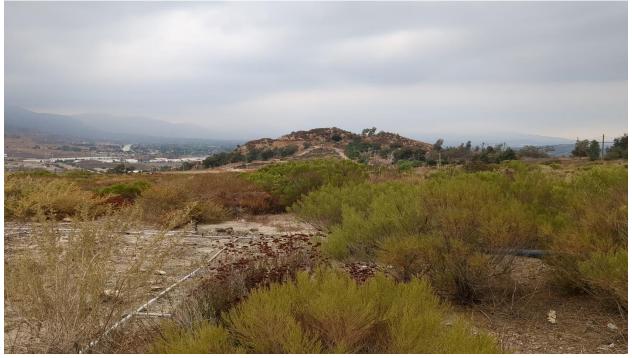
Photograph 3. Facing east at the Middle Deck from western boundary (September 18, 2025).

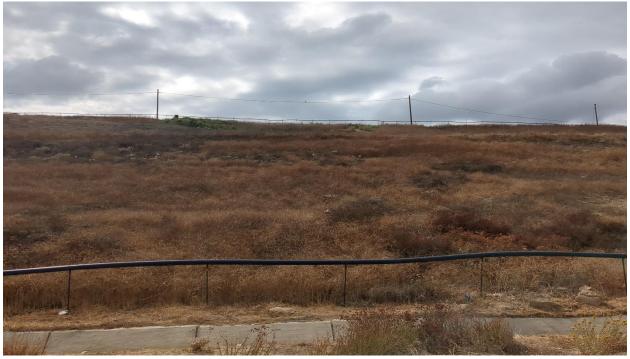
Photograph 4. Facing west at the easterly-facing slope located between the Middle and Upper decks. The vegetation on the slopes between the Middle and Upper deck is dominated by California buckwheat (currently fruiting) and non-native annual grasses (September 18, 2025).

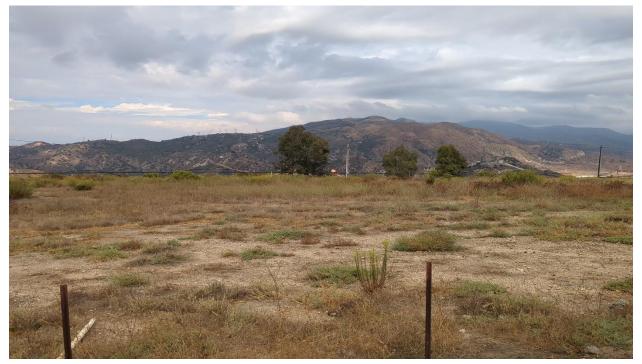
Overall, the Upper Deck (Deck A) continues to be sparsely covered with native vegetation due to compacted and poor soil conditions. However, in the southern-center of the Upper Deck, vegetation cover is higher than in other areas and includes native species such as California buckwheat, as well as non-native species such as red brome and short podded mustard. The presence of vegetation in the southern-center portion of the Upper Deck generally demonstrates that the soils in this area are suitable for supporting vegetation, both native and exotic. However, the soils elsewhere on the Upper Deck appear to be heavily compacted and gravelly, and vegetation coverage in these areas is sparse. Evidence of previous seeding is no longer discernible within the portions of the Upper Deck where plant establishment is visibly poor.

Photograph 5. Facing northeast at the Upper Deck. This area is compacted and gravelly and continues to be problematic for supporting vegetation. Non-native annual grasses and forbs, and California buckwheat shrubs are evident in the background (September 18, 2025).

• The vegetated areas on the Upper Deck that are currently dominated with non-native annual species have decent soil-texture conditions. These areas are less compacted than adjacent areas that are gravelly and mostly devoid of vegetation. In general, the soil texture within the vegetated areas with non-native vegetation is friable down to approximately 8-12 inches in depth. Various planting methods (i.e., planting container plants and hydroseeding) may be used to re-establish native plants on the Upper Deck where non-natives currently dominate.

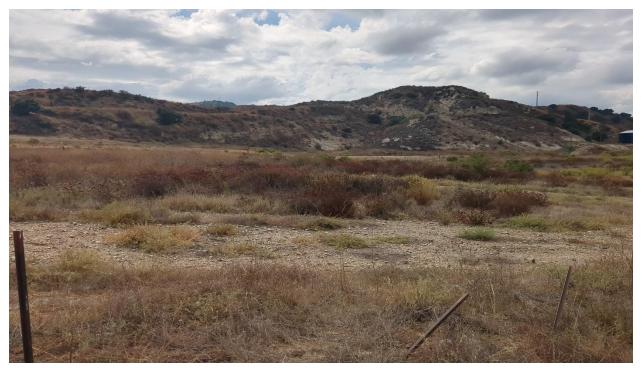
Photograph 6. Facing southwest at the Upper Deck. This area is primarily dominated by California buckwheat, wild oats, brome grasses, and short podded mustard (September 18, 2025).

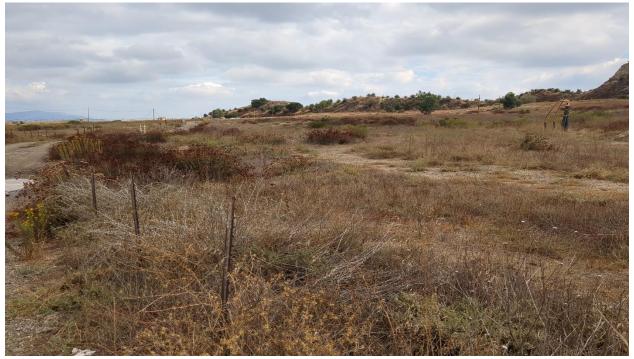
Photograph 7. Facing southeast at the western portion of the Upper Deck. This area is dominated by short podded mustard, Australian saltbush, and California buckwheat (June 23, 2025).

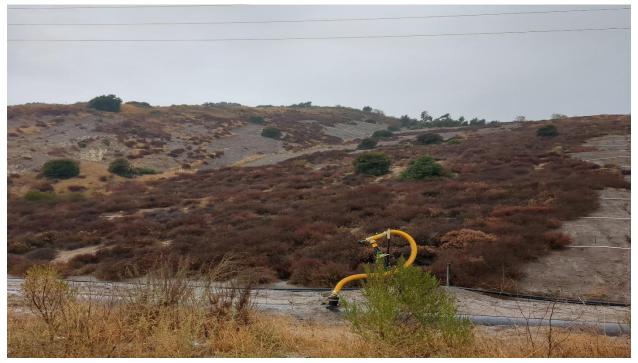
Photograph 1. Facing southwest at the County-Side Sage Mitigation Area (foreground), and the surrounding slope outside the mitigation area (background) (September 18, 2025).

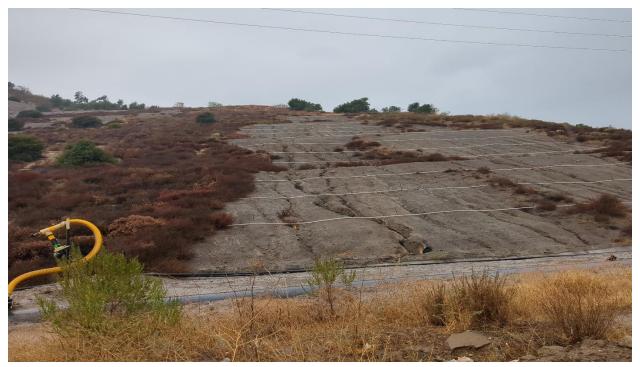
Germination and plant growth from hydroseeding that occurred several years ago is not discernible in some portions of the mitigation area. Conditions in the mitigation area have remained relatively unchanged since the first quarter of 2025. Areas that are moderately covered with native and non-native vegetation are concentrated in the southeastern portion of the mitigation area. The northern and upper portions of the mitigation area continue to be bare and problematic for establishment of vegetation, primarily because of highly eroded soils, steep slopes, and boron-toxic soils (see Recommendations section). However, there are some small patches of vegetation that have established in the northern-central portion of the mitigation area and include shrubs such as California buckwheat (Eriogonum fasciculatum), deerweed (Acmispon glaber), and California sagebrush (Artemisia californica).

Photograph 2. Facing northwest at the northern portion of the County-Side Sage Mitigation Area where plant growth has been problematic due to poor soil conditions (September 18, 2025).

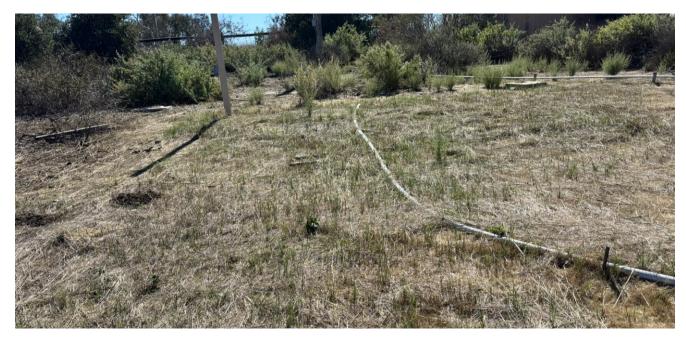
efforts some California Bush Sunflower along with Creeping Rye Grass were scalped. This was likely due to these shrubs being mistaken as dead since they are in their dormancy period. Efforts are being made to educate landscape maintenance crews to properly identify and differentiate between these plants in their dormancy from dead non-native plants that need to be removed. It was also recommended that the frequency of these weed abatements should increase during the winter and spring months to reduce non-native plant abundance.

Scalping of dormant native Creeping Rye Grass (Leymus triticoides)

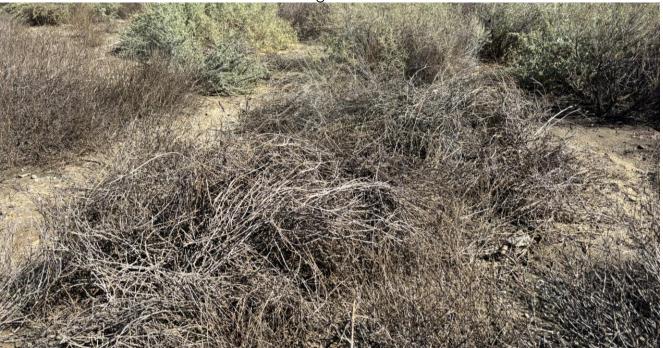
Native California Bush Sunflower (Encelia californica) removed and piled up on Deck C

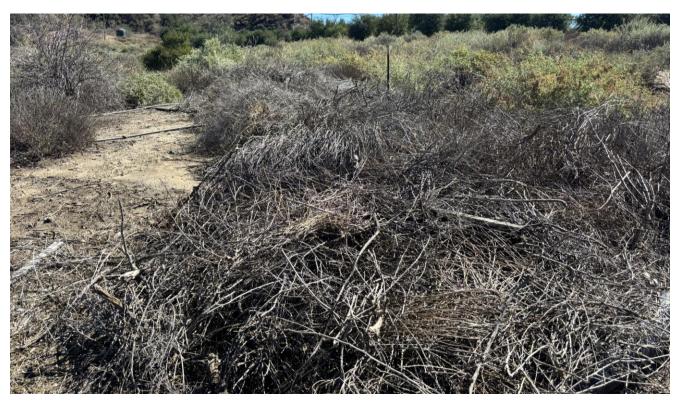
Native California Bush Sunflower (Encelia californica) removed and piled up on Deck C

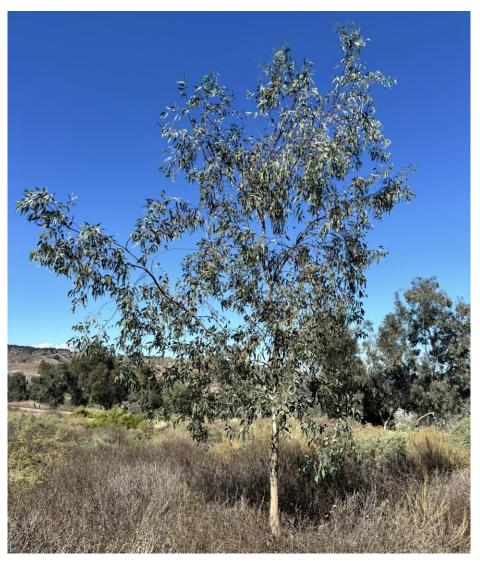
- Two large Eucalyptus (Eucalyptus sp.) are taking over on Deck C and should be removed immediately. These tree species have been photos and noted for removal for the last two years. Tree species should be removed from the deck to avoid overturning during high wind events.
- The PM10 Coast Live Oak trees are thriving and are well established along the south edge
 of Deck C. There are gaps in the berm planting where trees were burned during the
 Saddleridge Fire of 2019.

Eucalyptus tree growing on Deck C (To be removed)

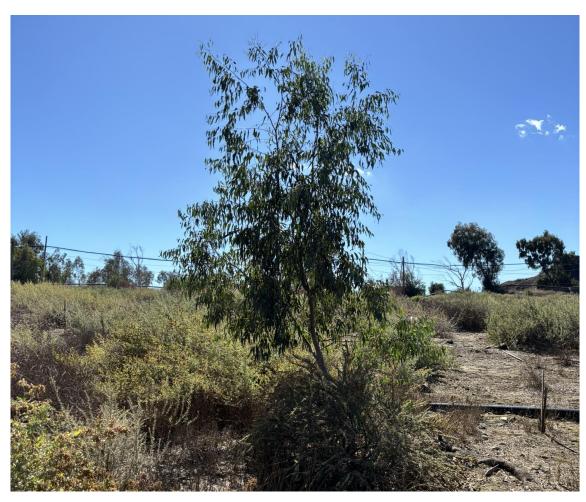
Eucalyptus tree growing on Deck C (To be removed)

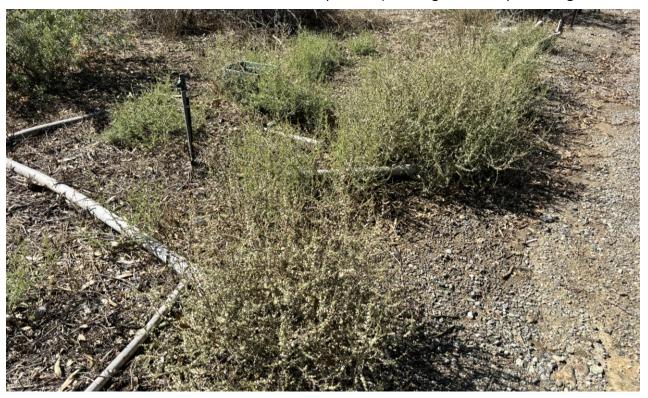
- There are areas of Shortpod Mustard (Hirschfeldia incana) and Russian Thistle (Salsola ssp.), beginning to reestablish on the east side of the deck. Additional weed species noted include: Yellow Thistle (Centaurea solstitialis), Horseweed (Erigeron canadensis), Tree Tabacco (Nicotiana glauca), Red Brome Grass (Bromus madritensis ssp rubens). The maintenance contractor should increase weeding frequency on the deck during the winter and spring months to minimize takeover. Do not leave weed seeds on the decks when performing weed abatement.

Invasive weed Russian Thistle (Salsola ssp.) on east side of Deck C (To be removed)

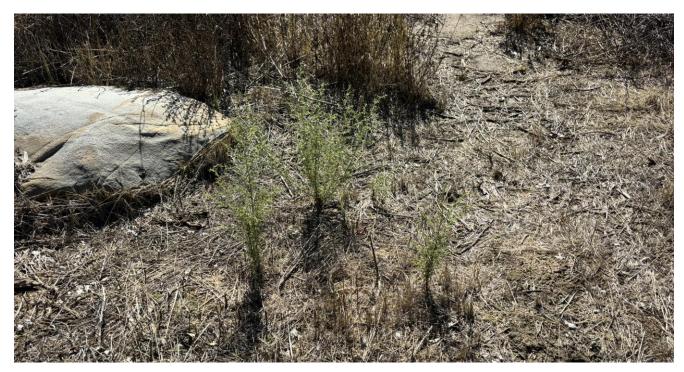
Seedlings & established Invasive weed California Stinkwort (*Dittrichia graveolens*) on Deck C (To be removed)

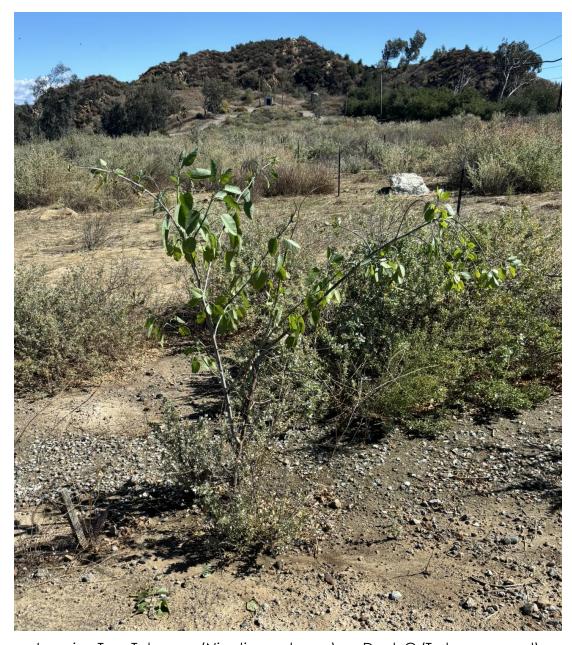
Invasive Tree Tabacco (Nicotiana glauca) on Deck C (To be removed)

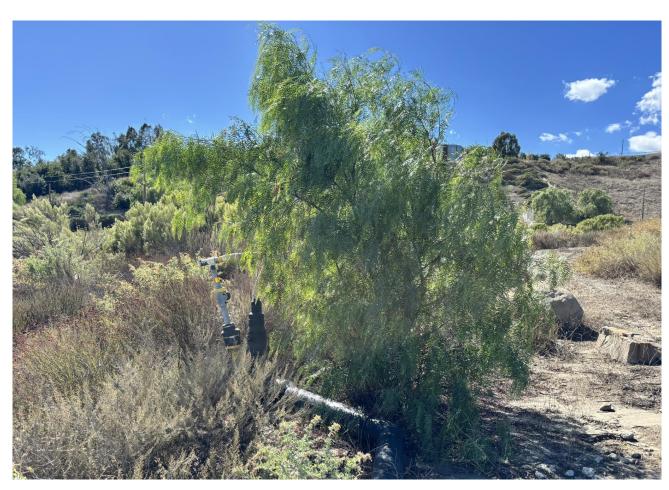
Overall, there is a good species diversity on this deck and planting is responding well with vigorous growth. It was also noted several California Pepper Trees (*Schinus molle*) and Saltcedar (*Tamarisk sp.*) should be removed.

Invasive California Pepper Trees (Schinus molle) on Deck B (To be Removed)

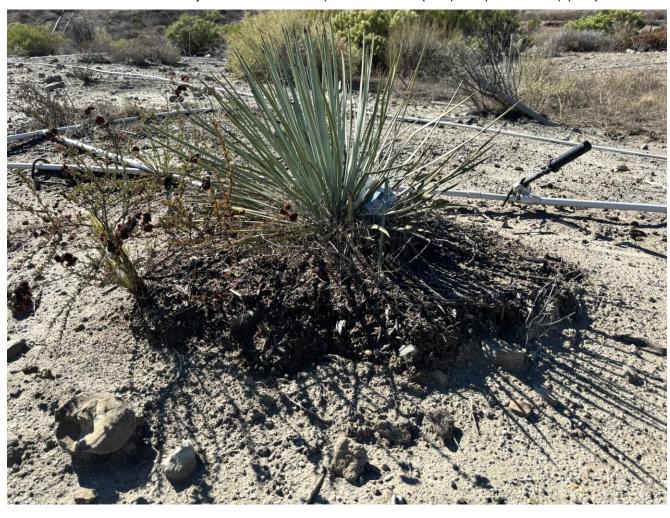
Erosion of soils adjacent to the Chaparral Yucca (Hesperoyucca whipplei)

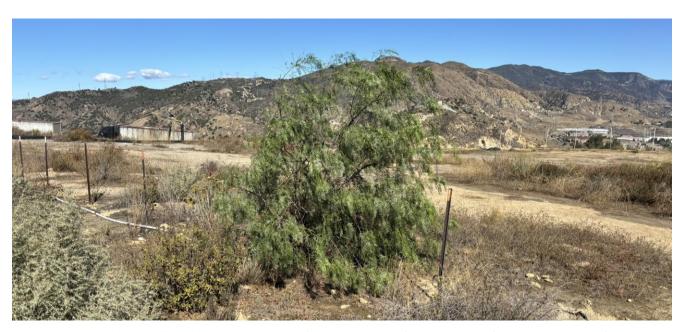
Invasive California Pepper Trees (Schinus molle) on Deck B (To be removed)

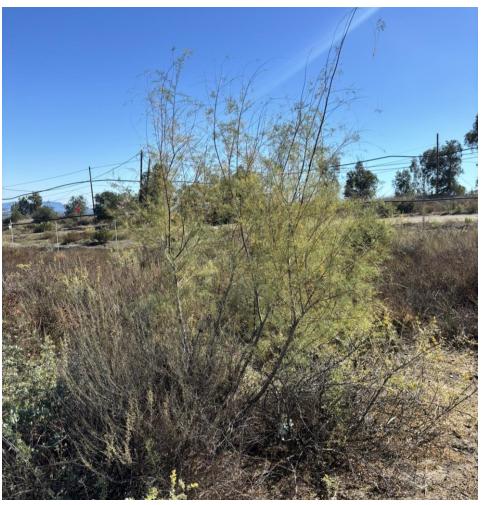
Invasive Salt Cedar (Tamarix species) on Deck B (To be removed)

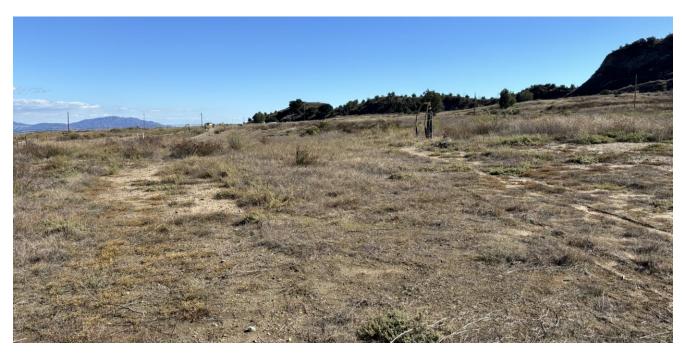
- The fill area previously repaired is vegetated with mostly exotic weeds, Russian Thistle (Salsola ssp.), Yellow Thistle (Centaurea solstitialis), Horseweed (Erigeron canadensis), Red Brome Grass (Bromus madritensis ssp rubens) and Shortpod Mustard (Hirschfeldia incana).
- Two newer areas on the deck where soil settlement occurred have been repaired.
 These areas should be seeded now that we are within the optimal time of the year for seed germination and native plant establishment.

Existing conditions of Deck A

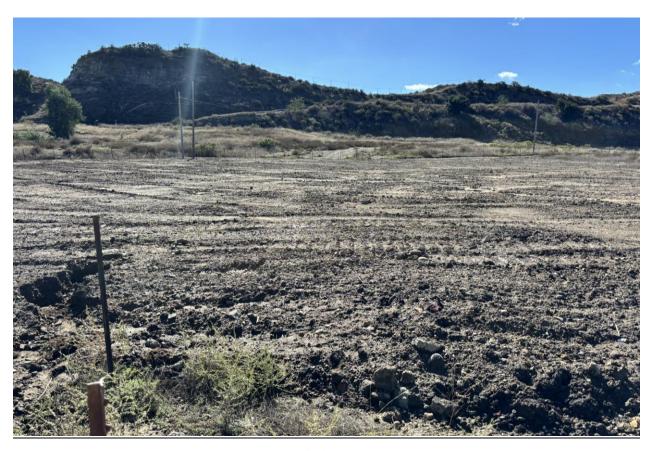
New grading on Deck A to fill in areas where settlement occurred
