April 30, 2026

Subject: Sunshine Canyon Landfill, Quarterly Vegetation Report
First Quarter 2026 Vegetation Report

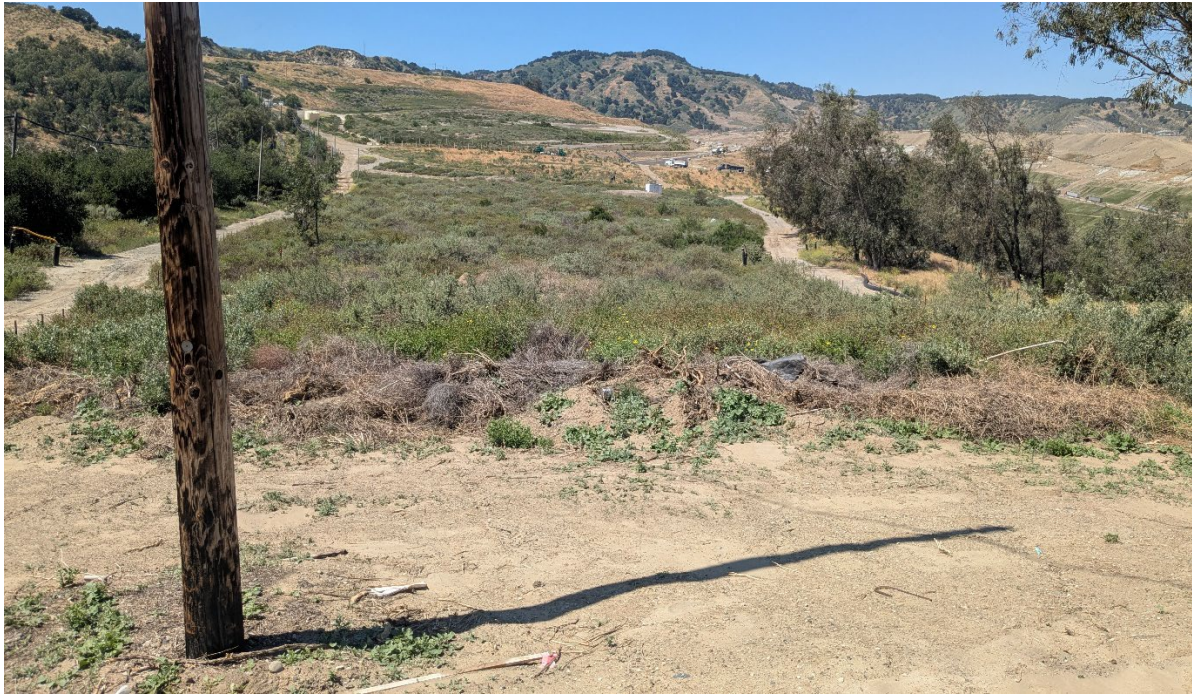
Photograph 1. Facing west at Lower Deck. View of eastern limits dominated by *Atriplex* spp. and California sunflower (April 7, 2026).

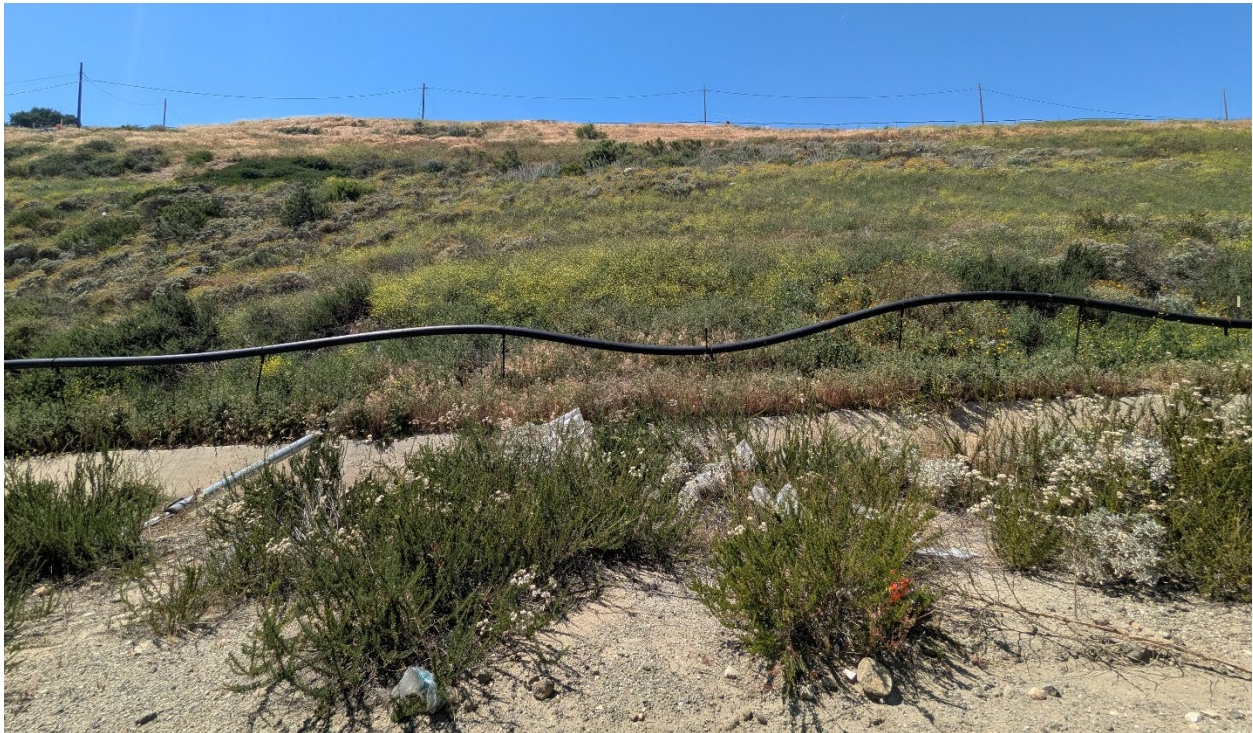
Photograph 4. Facing west at the easterly-facing slope located between the Middle and Upper Decks. The vegetation on the slopes between the Upper Deck is dominated by California buckwheat (currently vegetative) and non-native annual grasses (April 7, 2026).

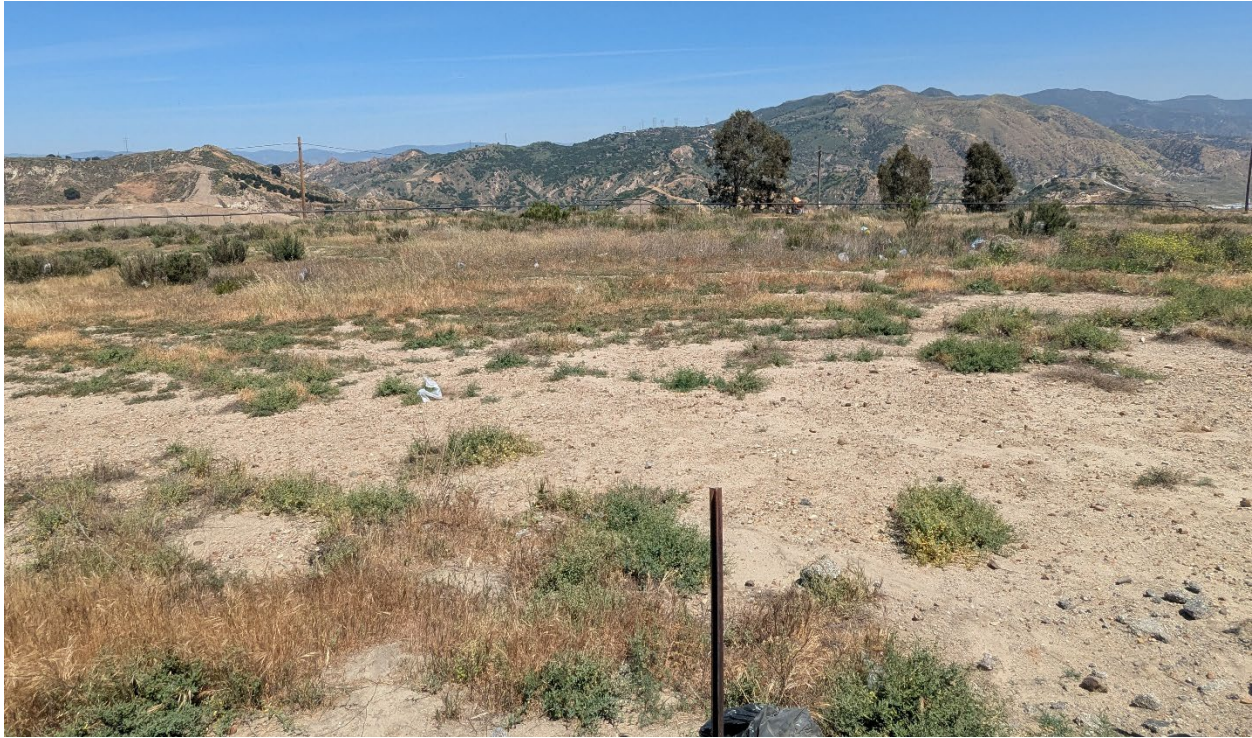
Photograph 5. Facing northeast at the Upper Deck. This area is compacted and gravelly and continues to be problematic for supporting vegetation. Non-native annual grasses and forbs, and California buckwheat shrubs are evident in the background (April 7, 2026.)

Improve Root Zone and Soil Conditions

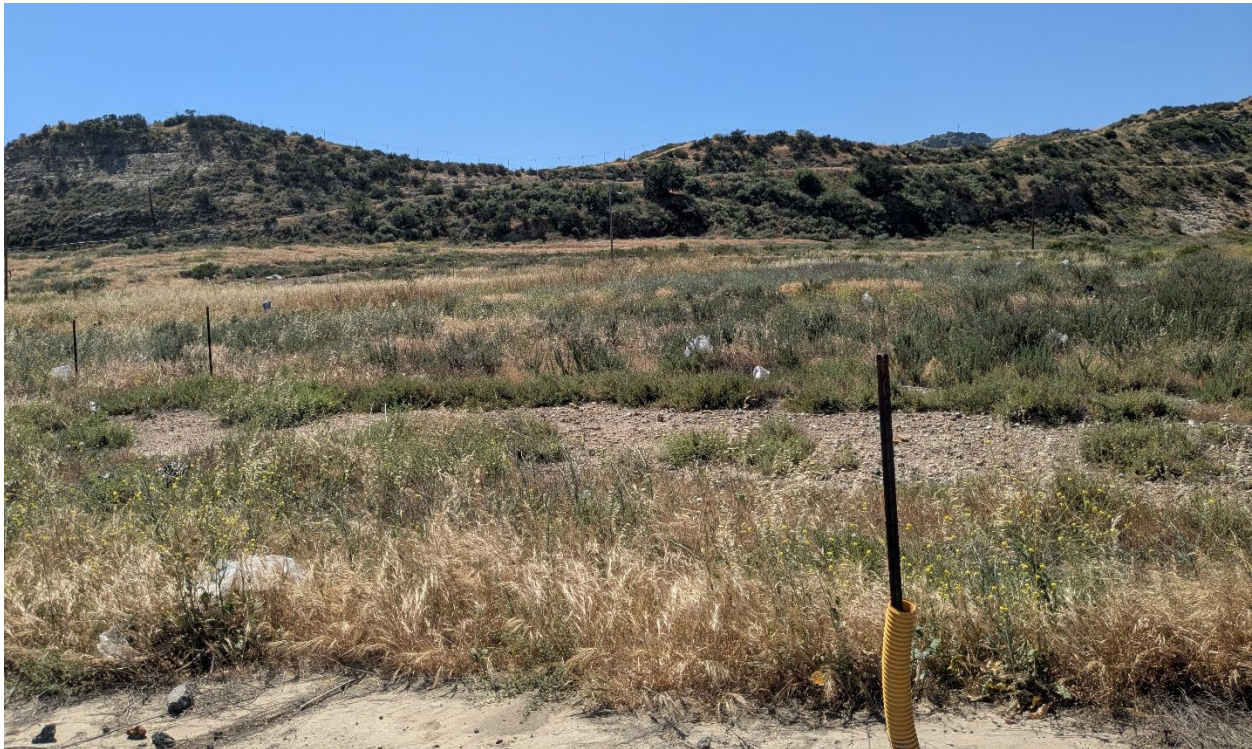
Photograph 6. Facing southwest at the Upper Deck. This area is primarily dominated by wild oats, brome grasses, redstem filaree, and short podded mustard (April 7, 2026).

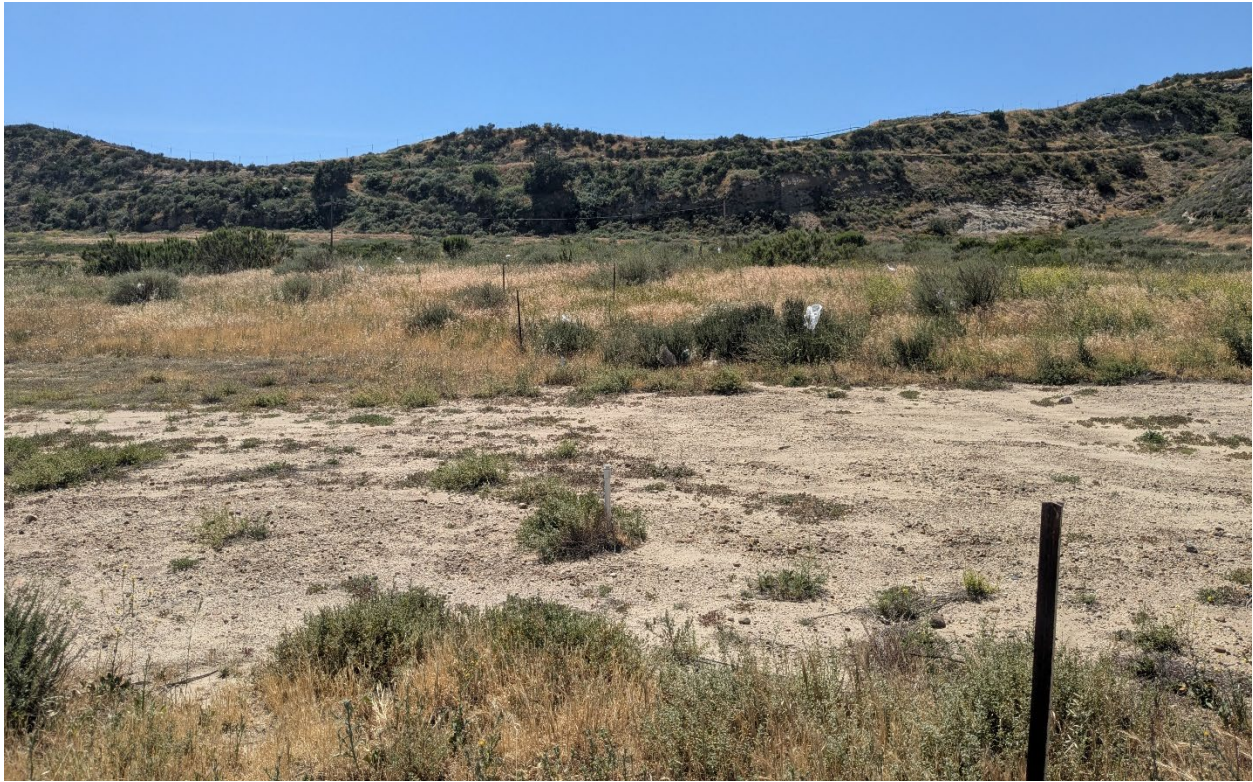
Photograph 7. Facing southeast at the western portion of the Upper Deck. This area is dominated by short podded mustard, Australian saltbush, and Russian thistle (April 7, 2026).

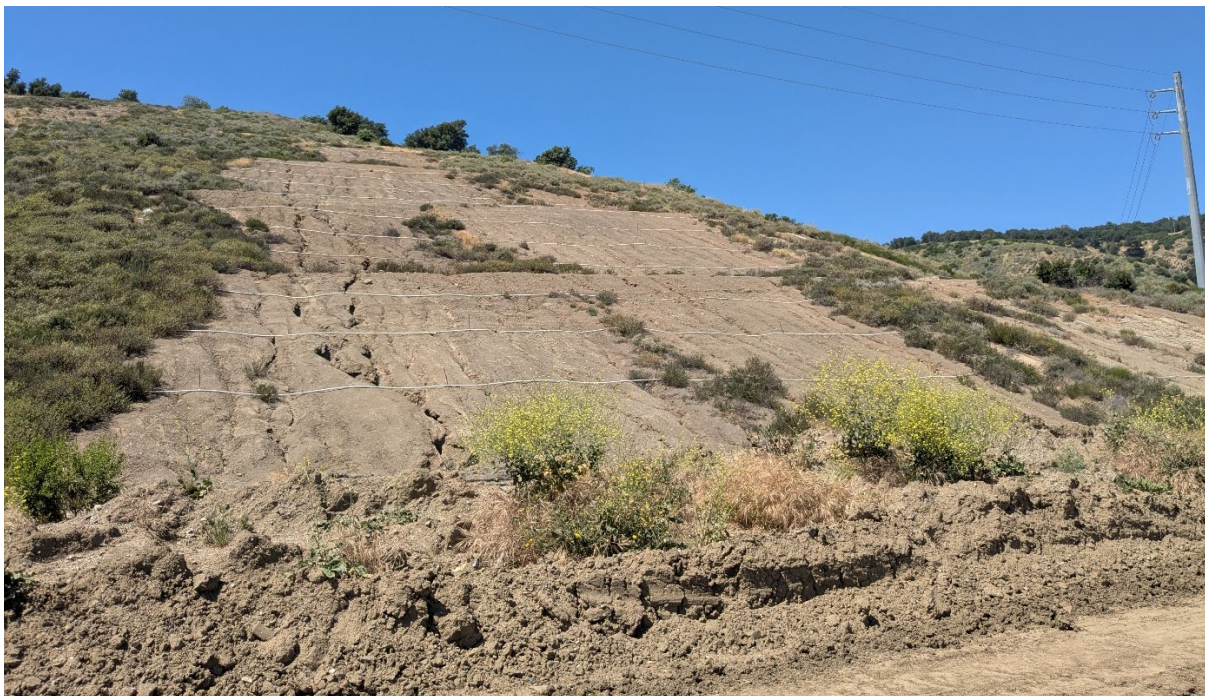
Photograph 2. Facing northwest at the northern portion of the County-Side Sage Mitigation Area where plant growth has been problematic due to poor soil conditions (April 7, 2026)

- **Create Benches.** Consider creation of several benches throughout the mitigation area to control soil erosion and to improve soil conditions to improve plant establishment and seed dispersal. This technique has been widely used on steep slopes and in areas where soil erosion is problematic. This technique also allows for opportunities to introduce a high-quality soil layer above the poor soils that exist.

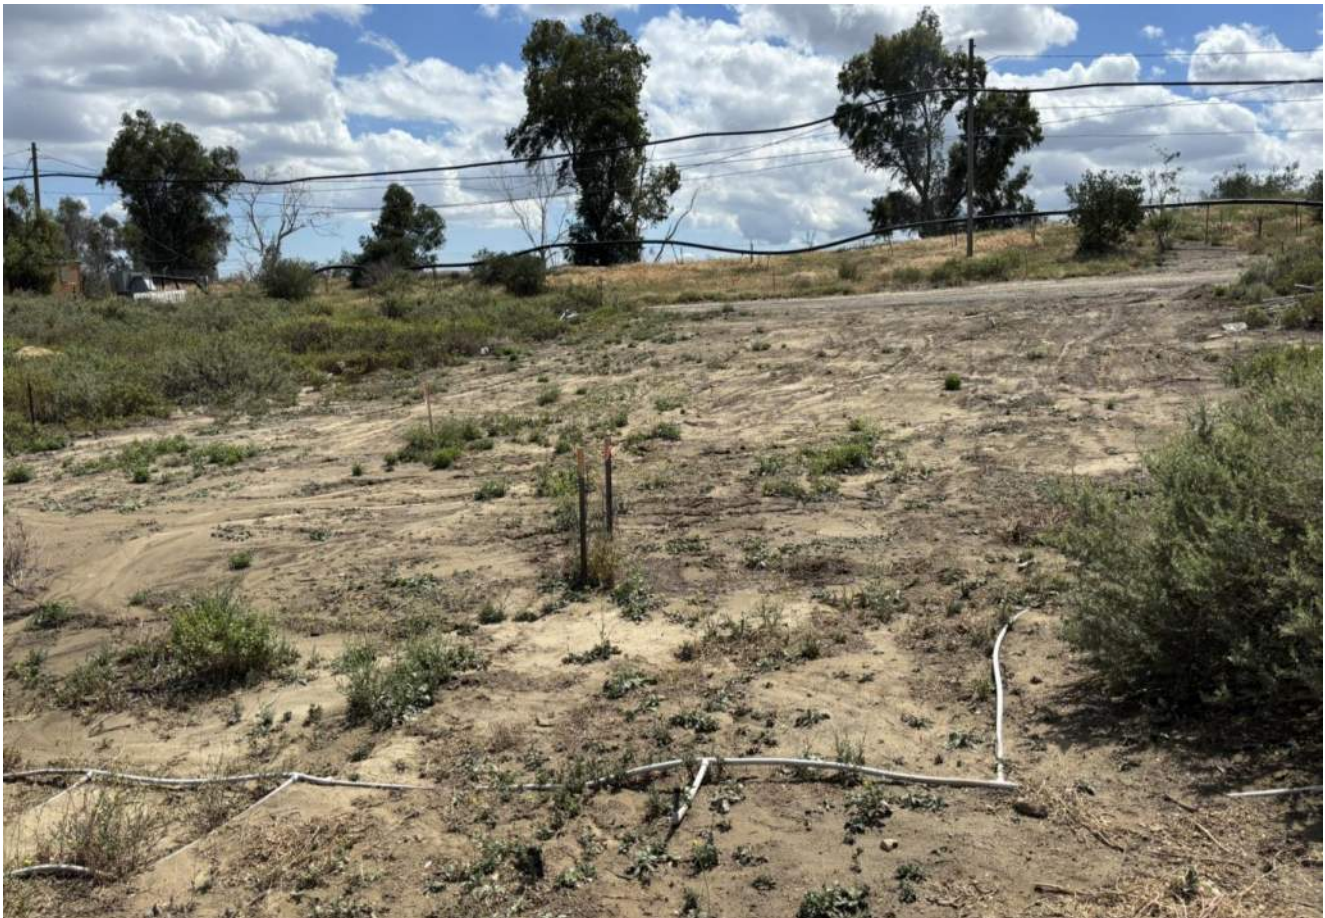
Recent grading activity and vegetation removal on Deck C southwest corner

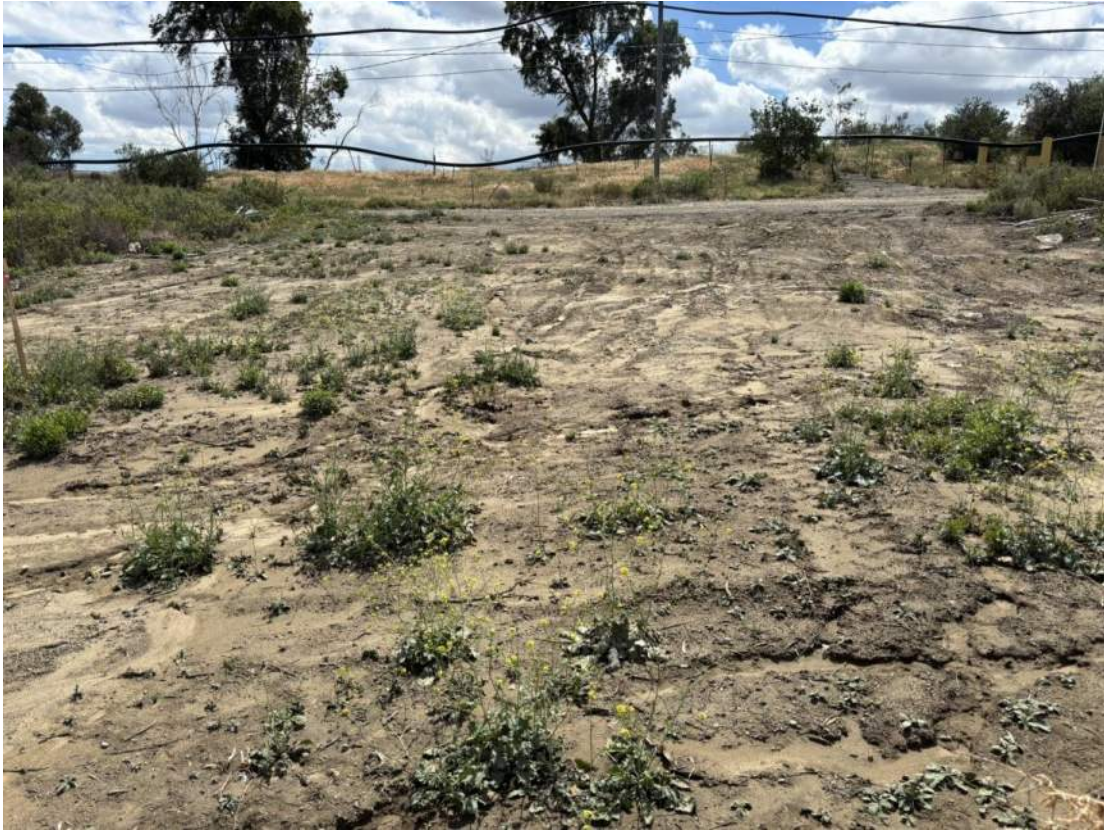
Invasive Shortpod Mustard (*Hirschfeldia incana*) growth at disturbed area

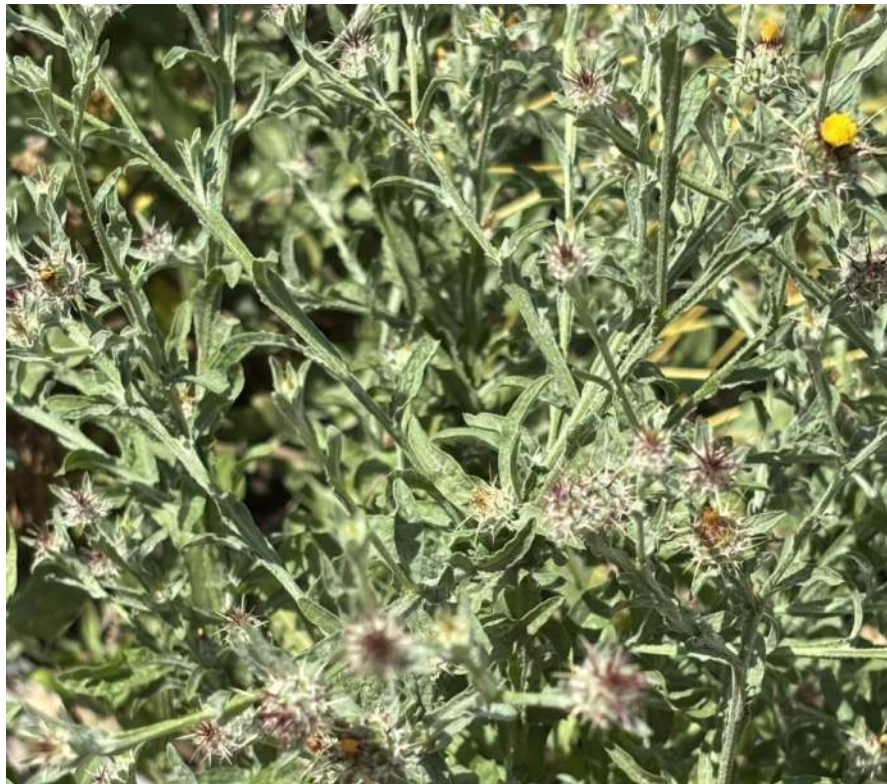
Invasive Yellow Star Thistle (*Centaurea solstitialis*) in bloom and seed phase

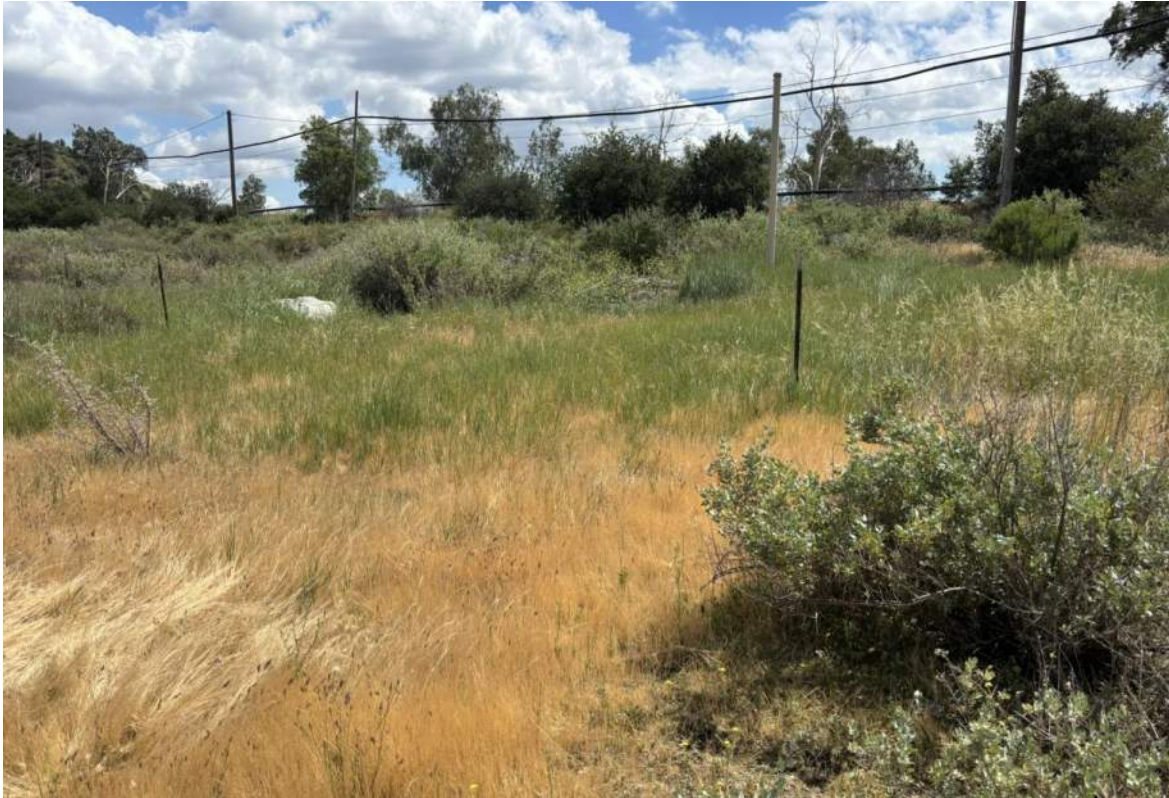
Previously scalped area of Creeping Rye Grass where vegetation has begun to return (green)
Invasive Rat's-tail Fescue (*Vulpia myuros*) seen in foreground (tan)

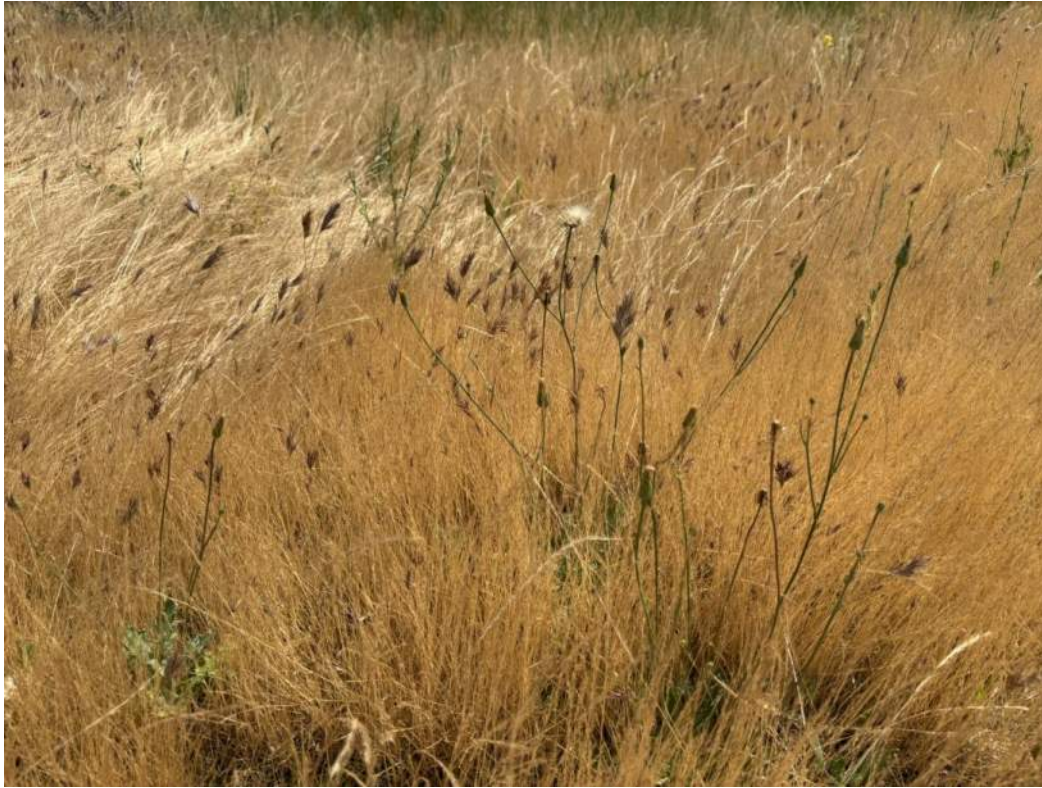
Invasive Rat's-tail Fescue (*Vulpia myuros*)(tan) and Smooth Cat's Ear (*Hypochaeris glabra*)

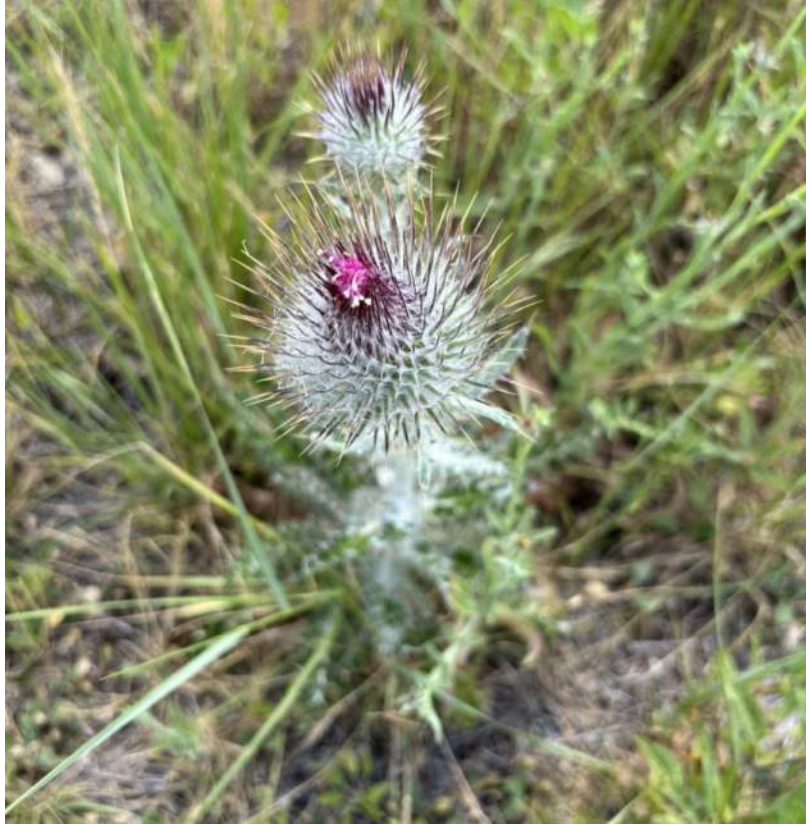
Invasive Cobwebby Thistle (*Cirsium occidentale*)

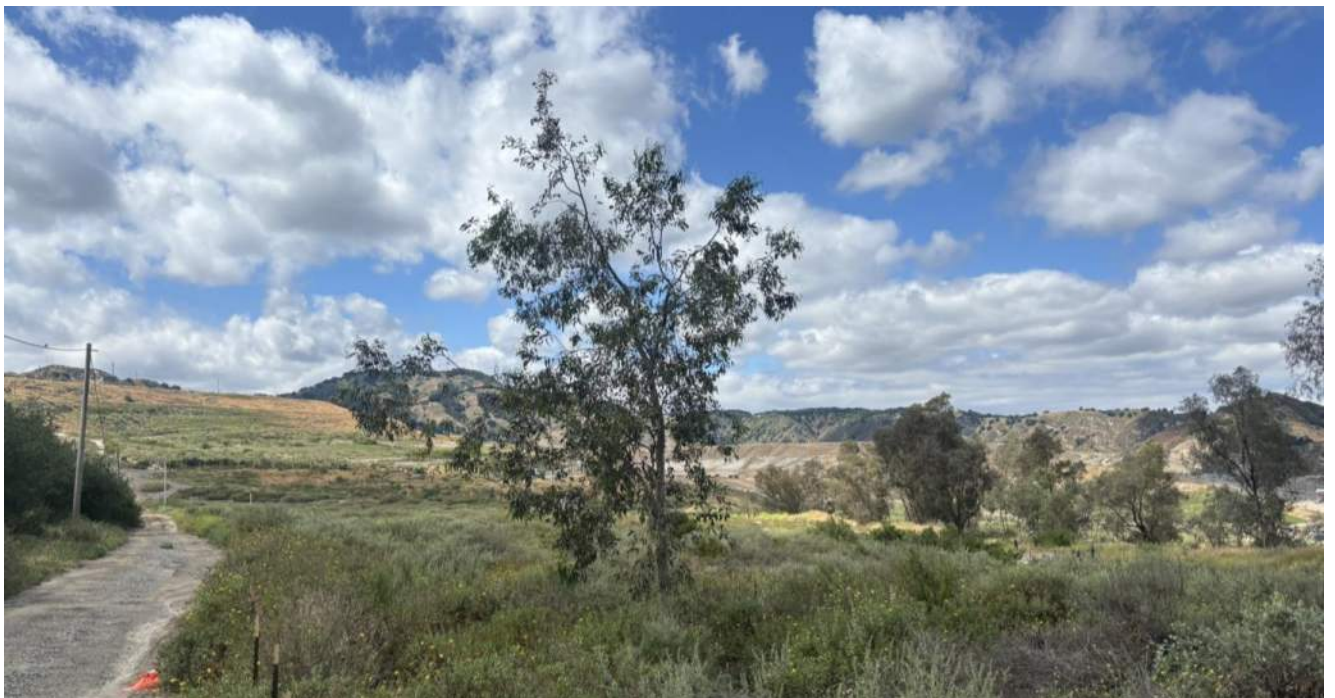
Previously documented Eucalyptus Tree (east end) for removal (height is +/- 20')

- The existing Eucalyptus trees have been documented in previous reports dating back several years. **There are at least two well established Eucalyptus that need to be removed to prevent the possibility of overturn and cap damage during high wind events.**
- Coast Live Oak Trees (*Quercus agrifolia*) along the PM10 Berm are healthy and actively growing. These trees are now well established, especially those which did not sustain significant damage during the Saddleridge Fire.

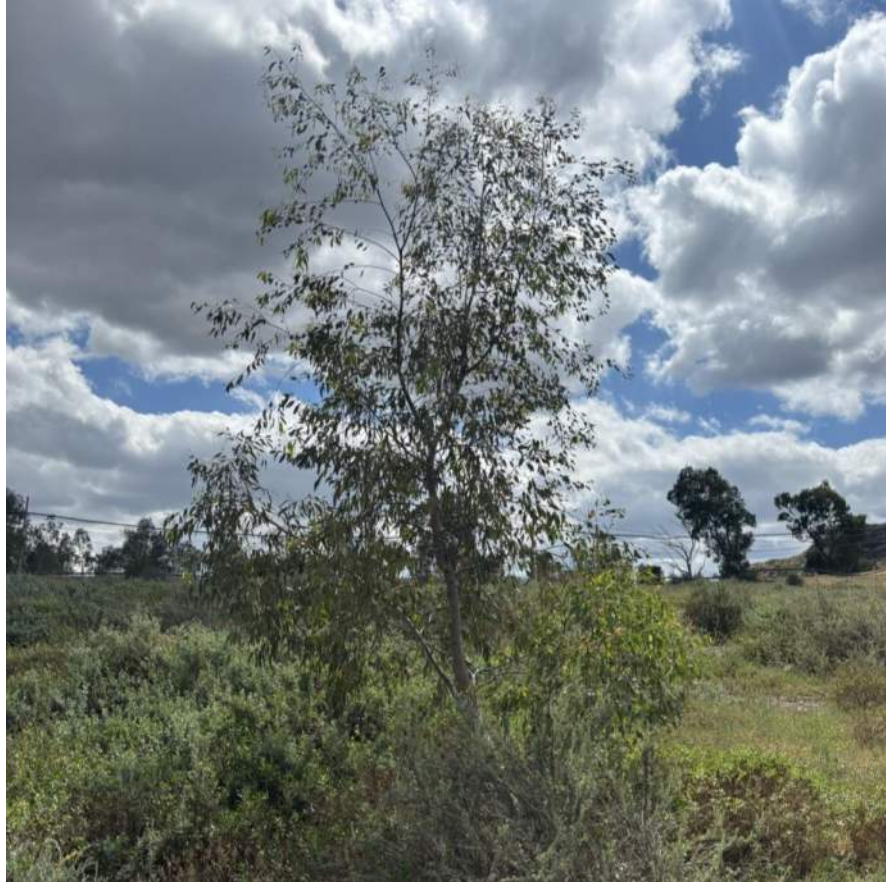
Previously documented Eucalyptus Tree (west end) for removal (height is +/- 20')

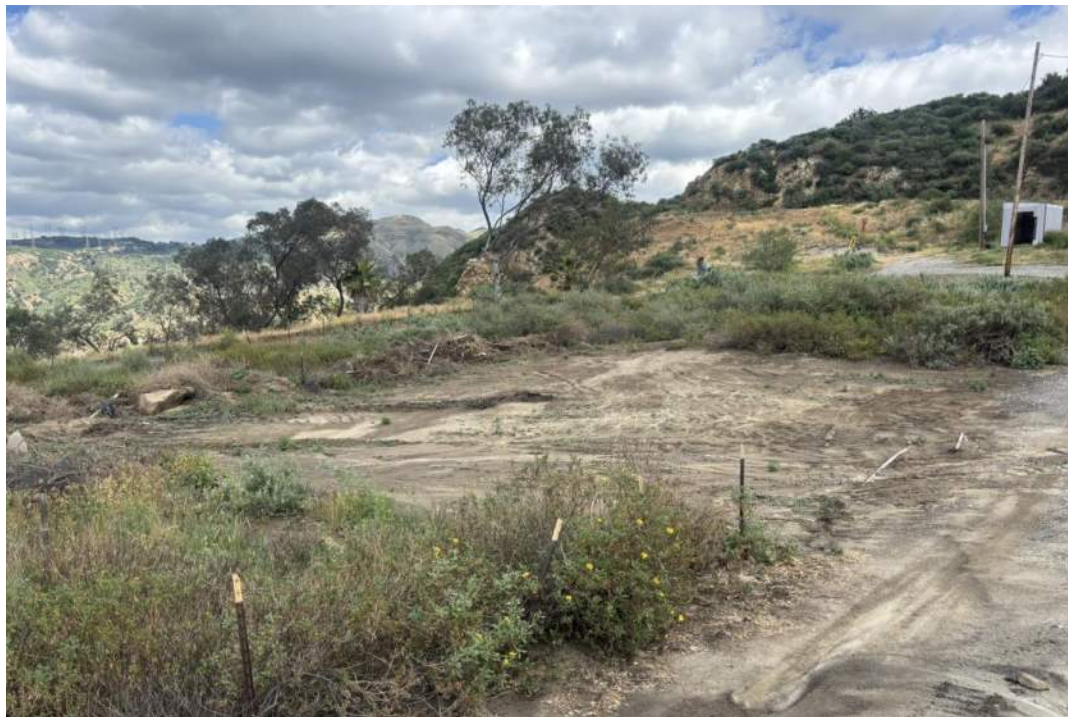
Recent grading activity and vegetation removal on Deck C east end

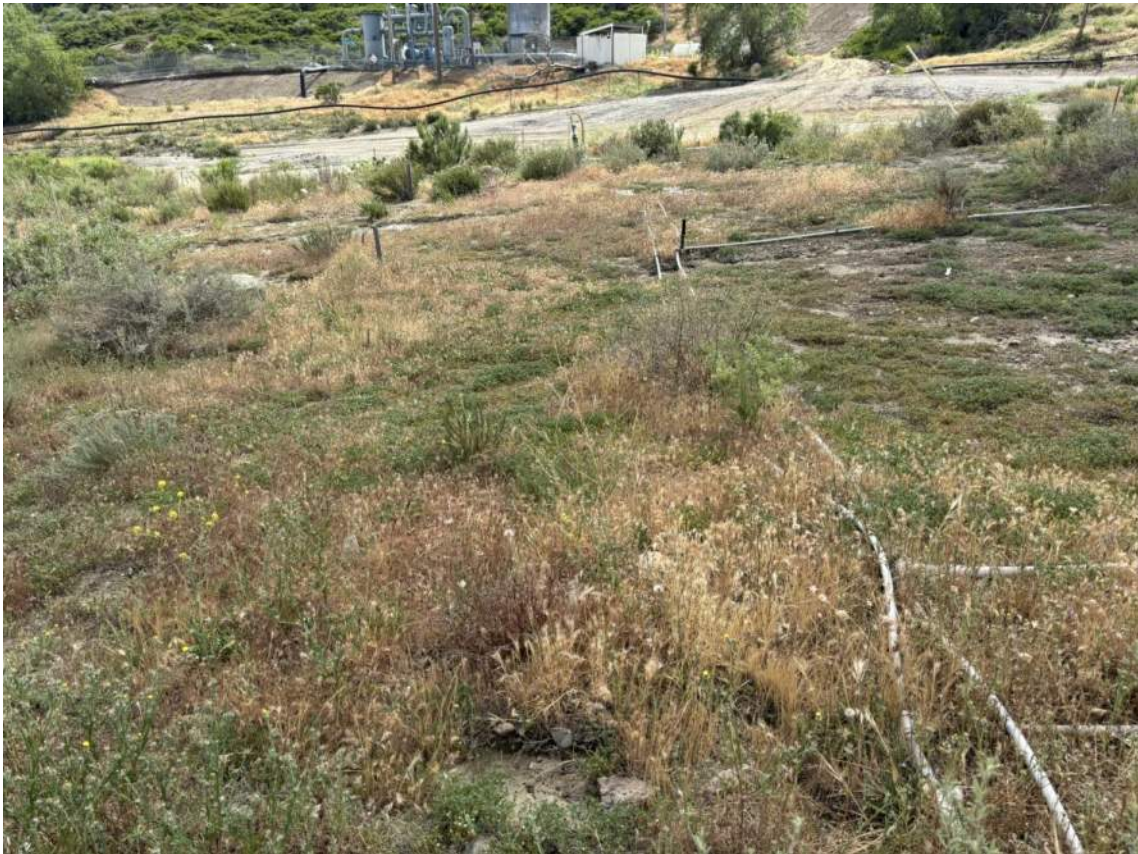
Invasive Shortpod Mustard (*Hirschfeldia incana*) and Yellow Star Thistle (*Centaurea solstitialis*) and Red Brome grass (*Bromus madritensis* ssp. *rubens*)

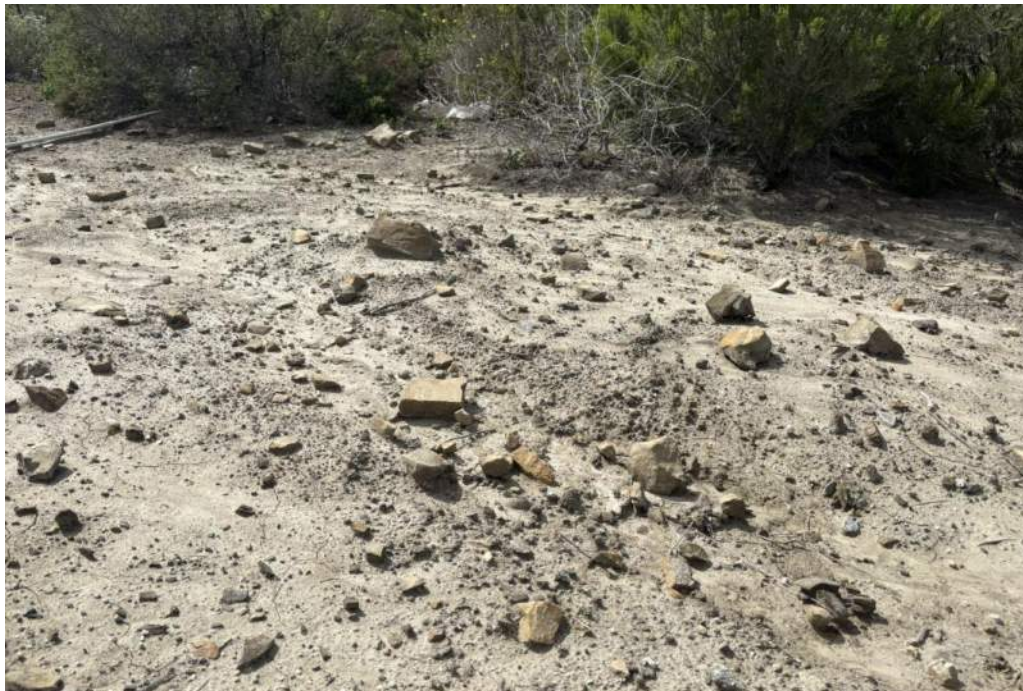
Barren dirt where topsoil has washed away leaving no vegetation

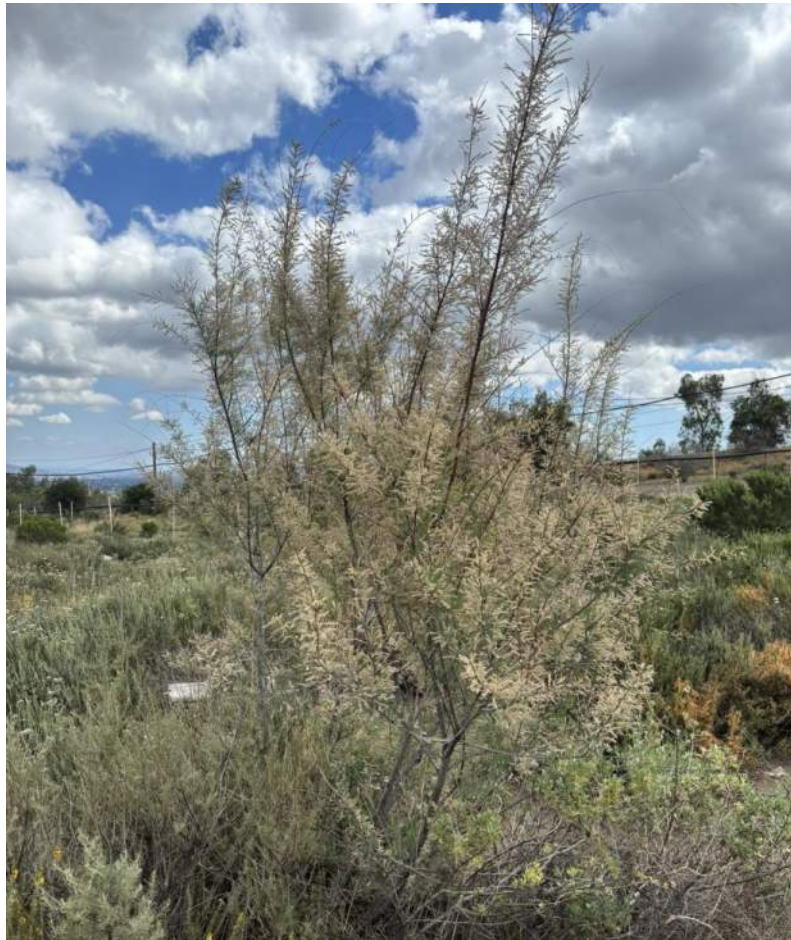
Invasive Tamarix that needs to be removed

Overall, there is a good species diversity on this deck and planting is responding well with vigorous growth. It was also noted numerous California Pepper Trees (*Schinus molle*) and Saltcedar (*Tamarisk sp.*) should be removed.

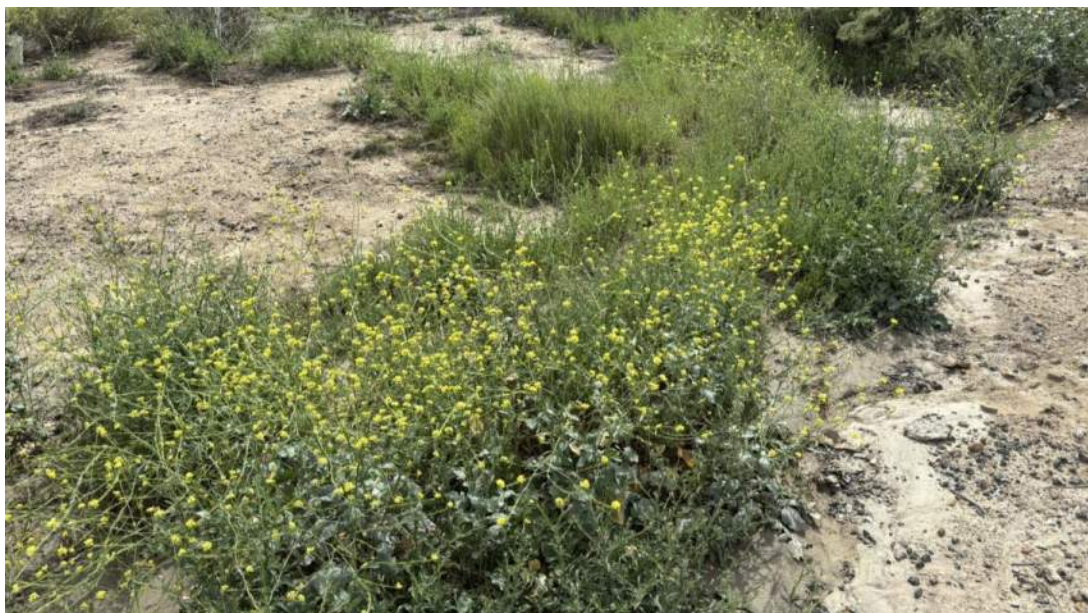
Flowering Invasive Shortpod Mustard (*Hirschfeldia incana*)

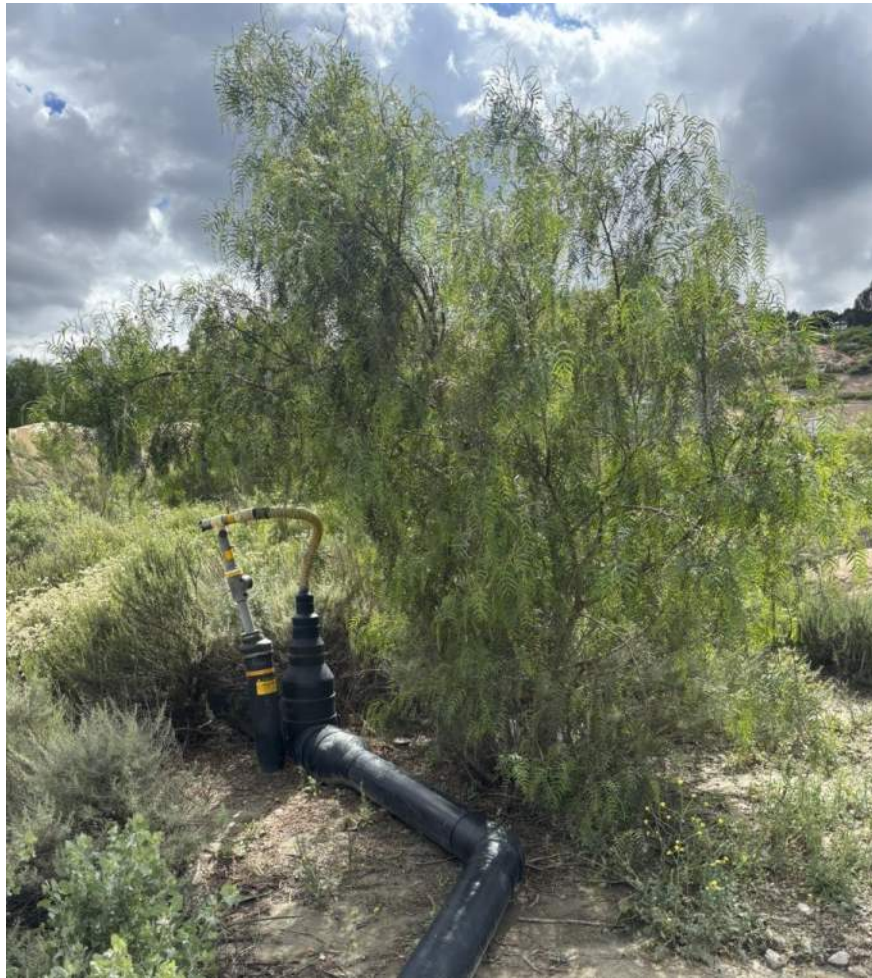
Invasive California Pepper Tree (*Schinus molle*) near gas well that needs to be removed
